**Corrosion of Bare and Coated Al 5052-H3 and Al 6061-T6 in Seawater**

L.H. Hihara and Kentaro Kusada  
Hawaii Corrosion Laboratory  
Department of Mechanical Engineering  
College of Engineering  
University of Hawaii at Manoa

Progress Report  
for:

September 17, 2011

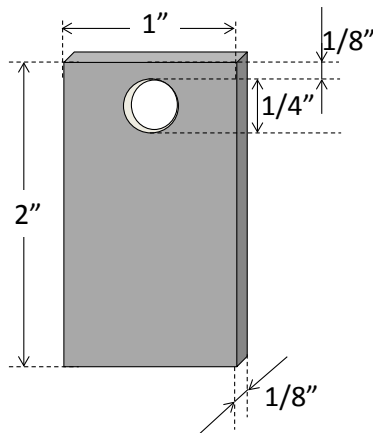
Test coupons were manufactured in the College of Engineering machine shop. A total of 624 coupons were processed for testing. Figure 1 shows the shape and size of the coupon.

Figure 1: Coupon dimensions

Manufacturing of the aluminum coupons was performed using the following procedure: Coupons were cut into 2.125" by 48" strips with hydraulic shear, and ground with 180 grit aluminum oxide paper. The strips were then sheared to produce 2.125" by

1.125” coupons. The coupons were then milled to a final size of 2” x 1” to remove the sheared edges.

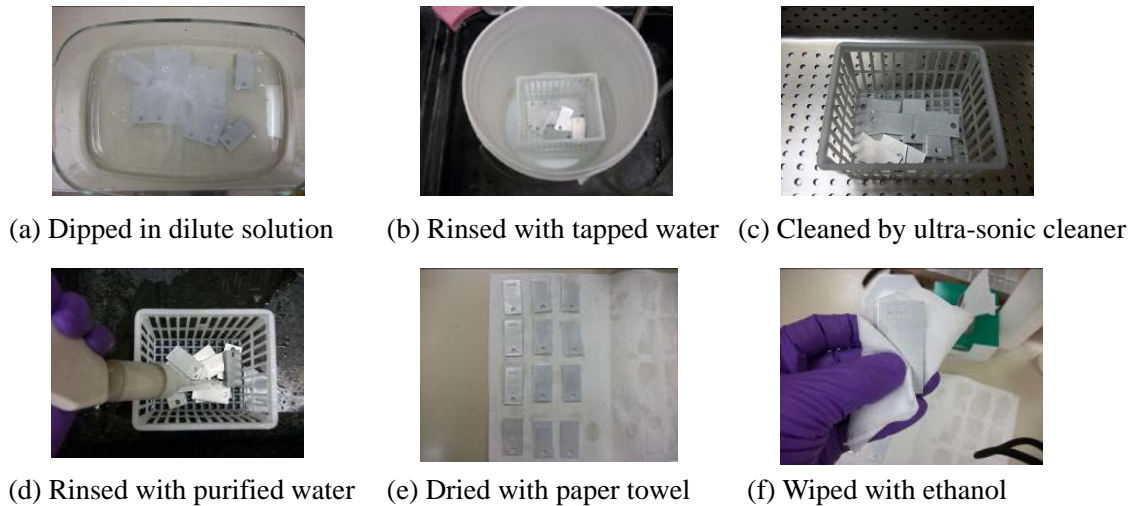
Surface preparation is required to improve coating adhesion. To remove oils, greases, salts, and other contaminants, a non-flammable phosphoric acid based cleaner designated as ALUMIPREP 33 (Henkel, USA) was used. The surface preparation was done as following steps: (1) ALUMIPREP 33 was diluted with purified water in 25 parts of ALUMIPREP 33 and 75 parts of water. (2) Coupons were dipped in the dilute ALUMIPREP 33 solution for 2 minutes (1 minute per side). (3) The coupons were then rinsed with water. (4) The coupons were cleaned in a sonic cleaner for 5 minutes. (5) The coupons were then rinsed with purified water. (6) The coupons were dried. (7) The coupons were finally wiped with ethanol. The procedure is shown in Figure 2.

Figure 2: Surface preparation

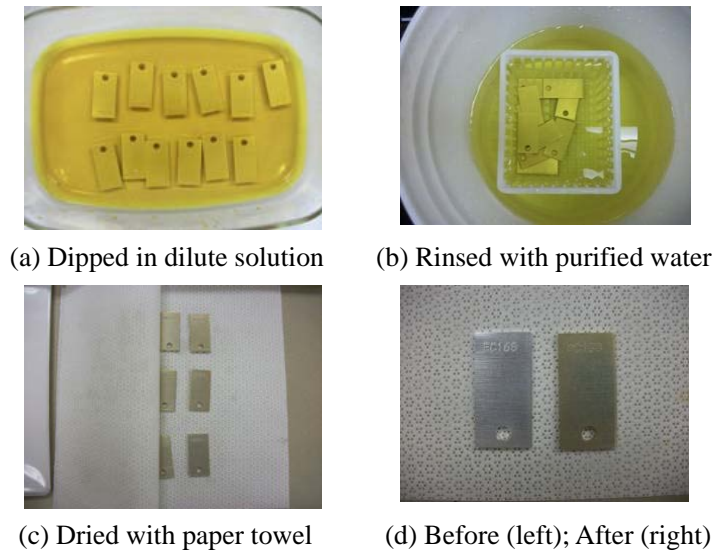
After surface preparation by ALUMIPREP 33, 198 of the 624 coupons were treated with Alodine 1201: (1) The ALODINE 1201 solution was prepared by mixing 25 parts of ALODINE 1201 and 75 parts of purified water. (2) Coupons were dipped for three minutes. (3) The coupons were rinsed with purified water. (4) The coupons were then dried. The procedure is shown in Figure 3.

Figure 3: Procedure for chromate conversion coating

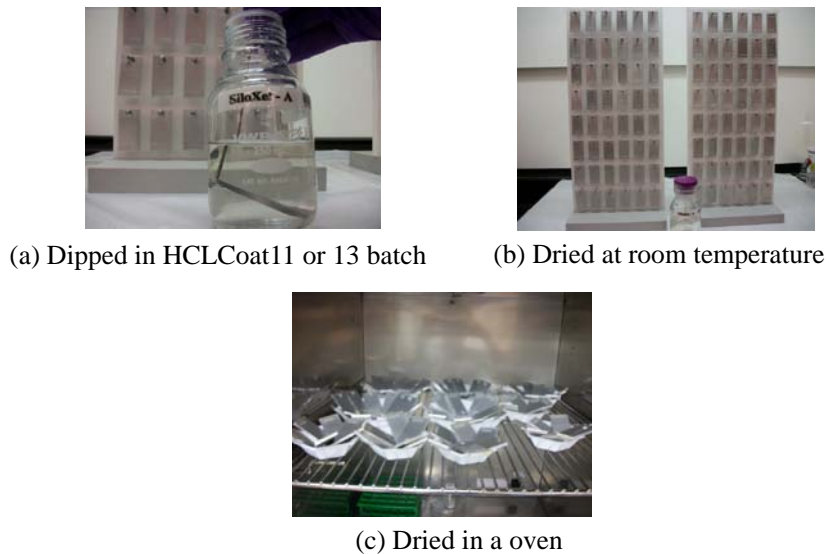
A total of 198 coupons were coated with HCLCoat11 and another 198 coupons were coated with HCLCoat13. Both coatings procedures were similar: (1) The coupons were dipped in HCLCoat11 or HCLCoat13 for 10 seconds. (2) The coupons were then cured at room temperature ( $\approx 25^{\circ}\text{C}$ ) for two days then at  $37^{\circ}\text{C}$  for four days. The procedure is shown in Figure 4. Complete curing can also be conducted at room temperature for one week.

Figure 4: Coating procedure of HCLCoat11 and HCLCoat13

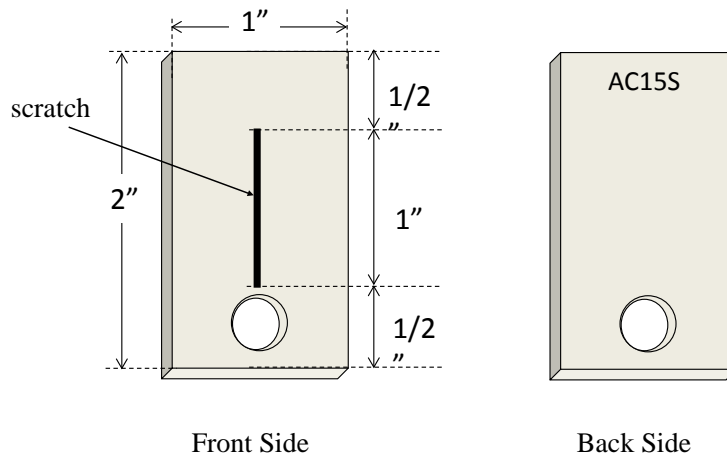
All coupons excluding bare coupons were scribed on one side as shown in Figure 5 to assess undercutting of the coating and localized corrosion.

Figure 5: Dimensions of the scratch on the coupon

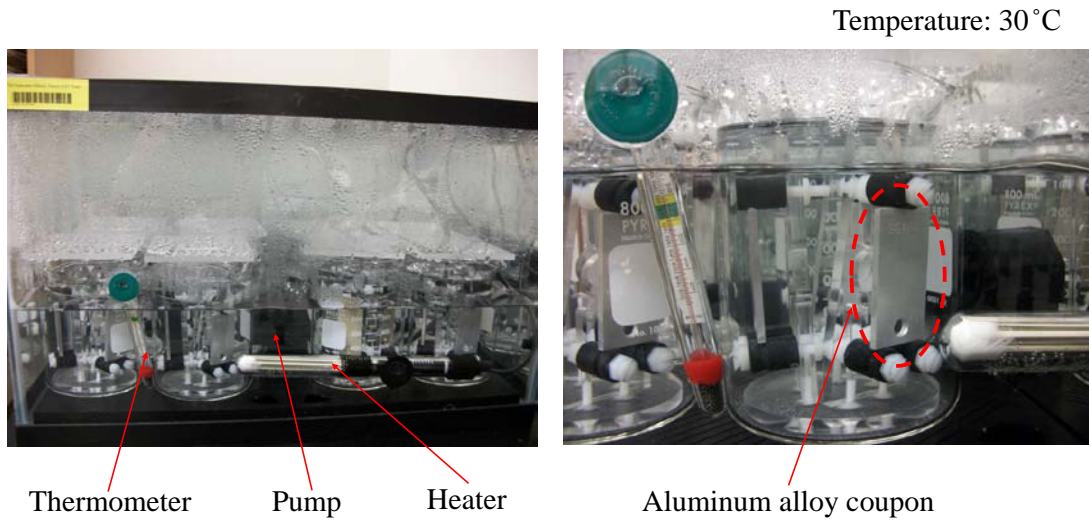
The setup for testing in artificial ASTM seawater is shown in Figure 6. The temperature of the artificial seawater is sustained at 30°C using a heater and water circulator (pump). The artificial seawater and specimens are contained in beakers with water circulation on the outside to maintain the exposure temperature of 30°C.

Figure 6: Artificial seawater immersion test

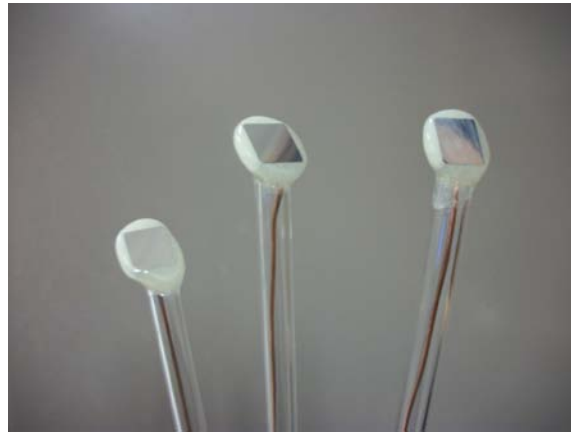
The following sections describe the procedure for fabricating the aluminum electrodes Figure 8.

Figure 8: Three electrodes; the metallic area is  $1\text{cm}^2$

Electrodes 1/8" thick, and 1.0 cm x 1.0 cm were cut from aluminum sheets. The electrodes were cut using a Buehler Isomet low speed saw with a Buehler diamond wafering blade (series 15 LC diamond). The corners of the electrode coupon were filleted by wet-grinding on a Buehler Ecomet 6 variable speed grinder-polisher using Buehler-Met II silicon carbide 180-grit grinding paper. The electrode coupon was attached to copper wire with silver conductive epoxy (MG Chemicals) and cured at 70°C for 20 minutes. The copper wire was shielded by using approximately 20 cm length of borosilicate glass tubing. A clear epoxy patch adhesive was used to seal the edges of the electrode, and attach the electrode to the glass tubing. Care was taken to ensure that the tubing end was sealed with epoxy, and that no copper wire was exposed. The epoxy was cured in the oven at 70°C for 1.5 hour, and then removed and allowed to cool to room temperature. The exposed face of the aluminum electrode coupon was wet-ground using Buehler Ecomet 6 variable speed grinder-polisher. The grinding sequence was done sequentially as follows: 180-grit, 320-grit, and 600-grit. All of the grinding papers used were Buehler-Met II silicon carbide grinding paper. After grinding with 600-grit paper, the electrode coupon surface was rinsed with purified water. Polishing was done on the Buehler Ecomet 6 variable speed grinder-polisher in the following sequence: 1 $\mu\text{m}$  and 0.3 $\mu\text{m}$  Buehler de-agglomerated alpha alumina.

To investigate the electrochemical properties of the aluminum alloy coated with the ceramer coating, the electrodes were coated with either HCLCoat11 or HCLCoat13. Bare electrodes were dipped into HCLCoat11 or HCLCoat13 for 10 seconds. The coated electrodes were then dried at room temperature of 25°C for 2 days, and then placed in a dry box.

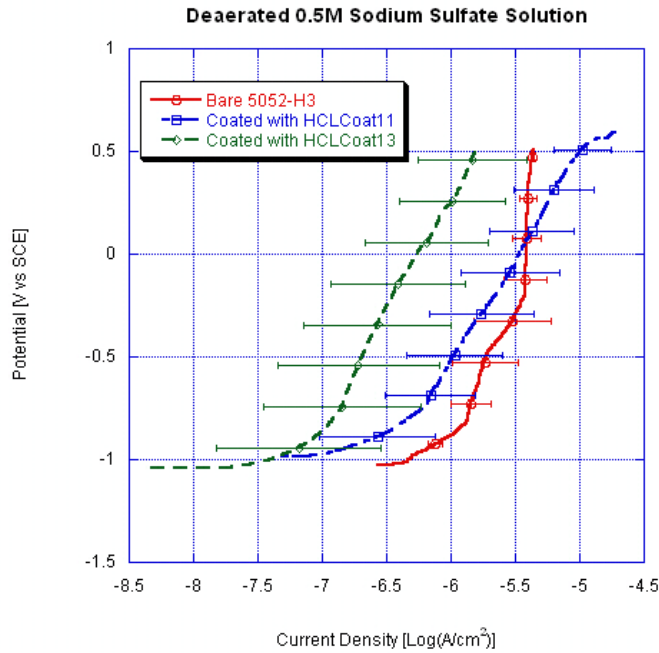
Anodic polarization diagrams for bare, HCLCoat11-coated, and HCLCoat13-coated Al 5052-H3 electrodes are compared in Figures 9 and 10.

Both HCLCoat11 and HCLCoat13 generally suppressed the dissolution rate of the Al 5052 substrate from the open-circuit potential to 0  $V_{SCE}$  (deaerated) and 0.5  $V_{SCE}$  (aerated). However, there was significant scatter in the data for the coated specimens, and additional polarization tests are planned.

Figure 9: Comparison of mean anodic polarization diagrams of bare, HCLCoat11, HCLCoat13 coated Al 5052-H3 in deaerated 0.5M sodium sulfate solution at 25.5°C

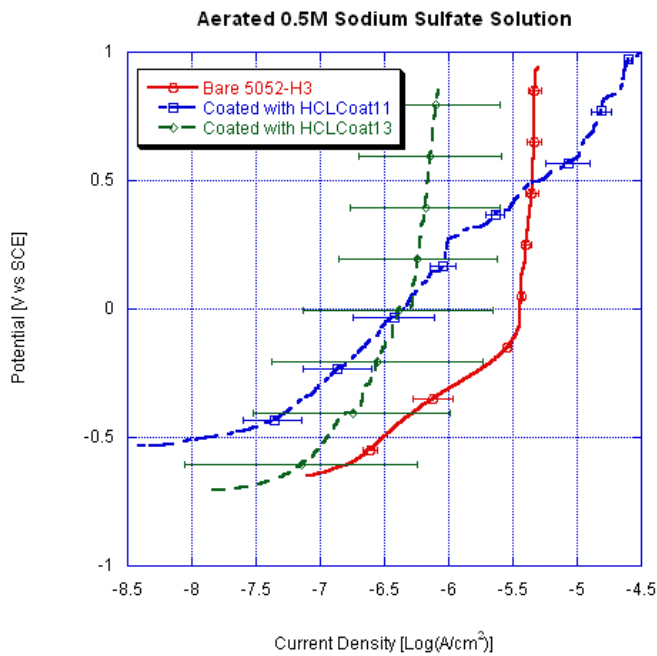
Figure 10: Comparison of mean anodic polarization diagrams of bare, HCLCoat11, HCLCoat13 coated Al 5052-H3 in aerated 0.5M sodium sulfate solution at 25.5°C

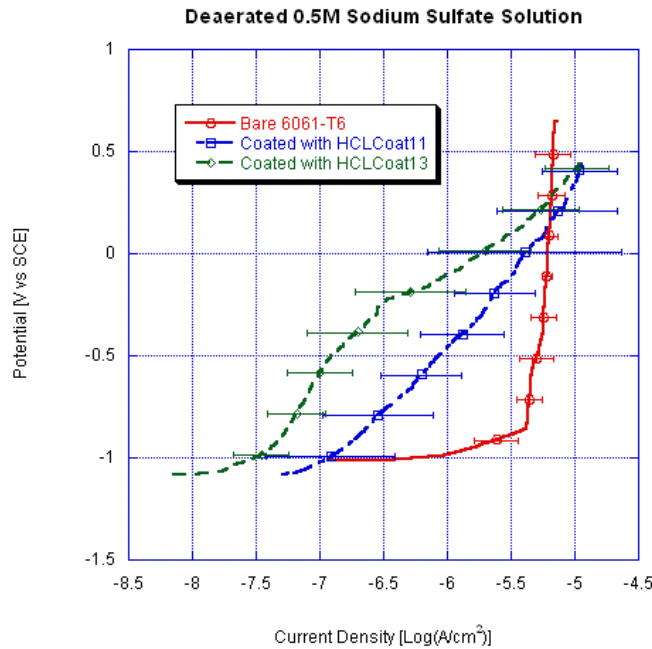
Anodic polarization diagrams for bare, HCLCoat11 coated, and HCLCoat13 coated Al 6061-T6 electrodes are compared in Figures 11 and 12.

Figure 11: Comparison of mean anodic polarization diagrams of bare, HCLCoat11, HCLCoat13 coated Al 6061-T6 in deaerated 0.5M sodium sulfate solution at 25.5°C

Both HCLCoat11 and HCLCoat13 generally suppressed the dissolution rate of the Al Al 6061 substrate from the open-circuit potential to 0.25 V<sub>SCE</sub> (deaerated and aerated). However, there was significant scatter in the data for the coated specimens, and additional polarization tests are planned.

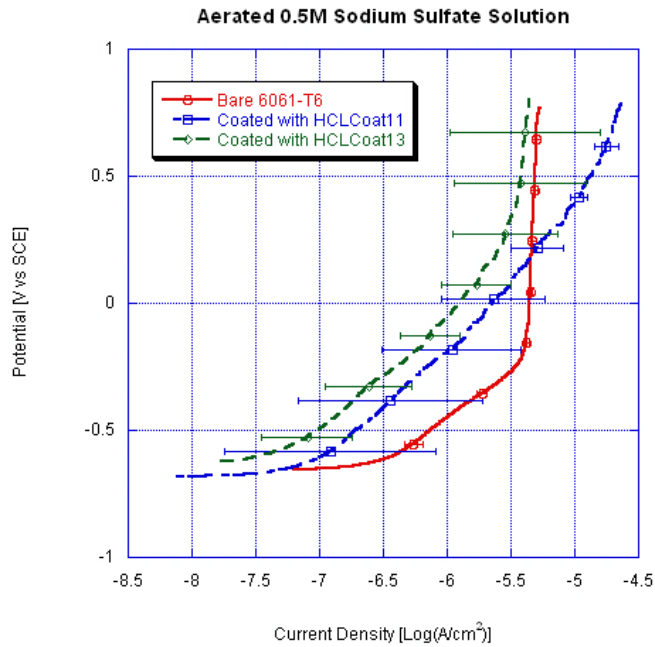
Figure 12: Comparison of mean anodic polarization diagrams of bare, HCLCoat11, HCLCoat13 coated Al 6061-T6 in aerated 0.5M sodium sulfate solution at 25.5°C

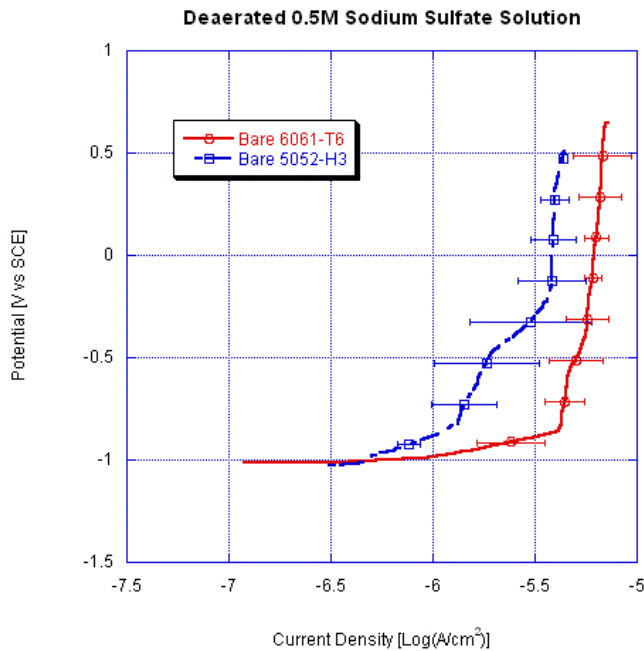
The comparison of anodic polarization diagrams of bare Al 5052-H3 and Al 6061-T6 are shown in Figure 13 and 14. Al 5052-H3 alloy has slightly lower passive current densities compared to Al 6061-T6.

Figure 13: Comparison of mean anodic polarization diagrams of bare Al 5052-H3 and Al 6061-T6 in deaerated 0.5M sodium sulfate solution at 25.5°C

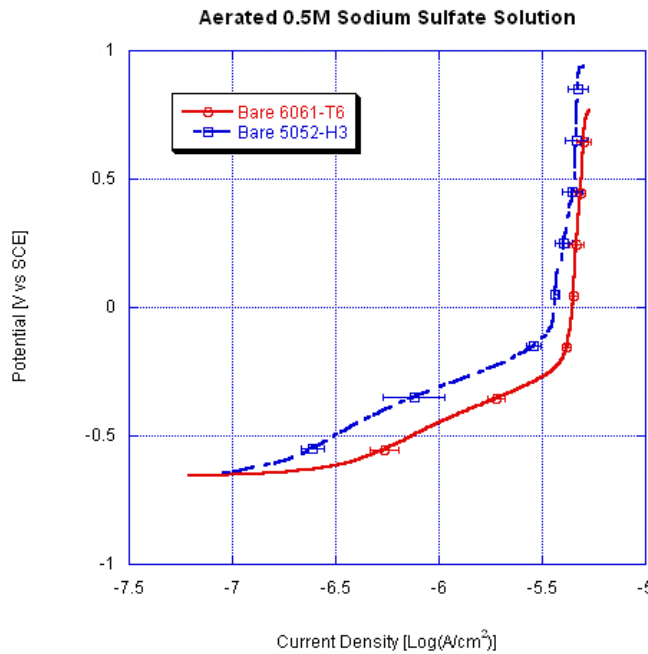
Figure 14: Comparison of mean anodic polarization diagrams of bare Al 5052-H3 and Al 6061-T6 in aerated 0.5M sodium sulfate solution at 25.5°C

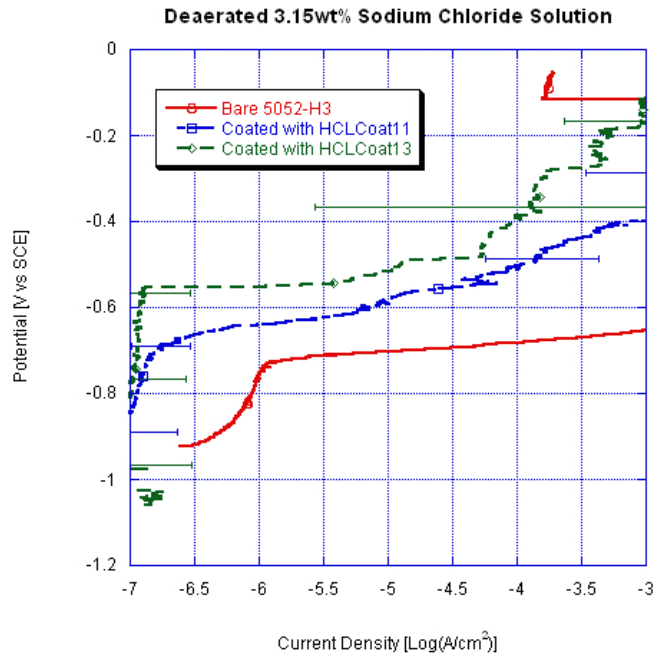
Anodic polarization diagrams for bare, HCLCoat11-coated, and HCLCoat13-coated Al 5052-H3 electrodes are compared in deaerated (Figure 15) and aerated (Figure 16) 3.15 wt% NaCl.

On bare Al 5052 in deaerated 3.15wt% NaCl solution, the pitting potential was approximately  $-0.73V_{SCE}$ . In aerated 3.15wt% NaCl solution, oxygen reduction polarizes the Al 5052 to its pitting potential, which is coincident with the open-circuit potential.

For electrodes coated with HCLCoat11 and HCLCoat13, their pitting potentials are almost same as the bare electrodes; however, the current densities are less by 1 to 2 orders of magnitude.

Figure 15: Comparison of mean anodic polarization diagrams of bare, HCLCoat11-coated, and HCLCoat13-coated Al 5052-H3 in deaerated 3.15wt% NaCl solution at 25.5°C

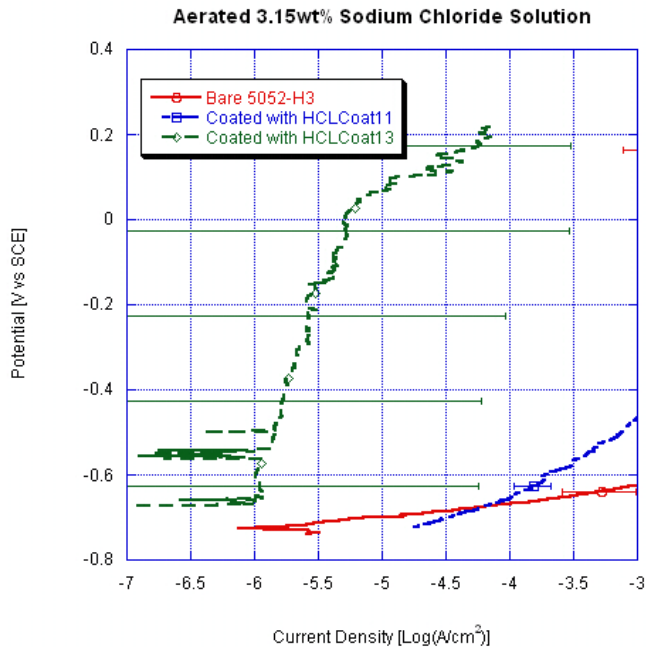
Figure 16: Comparison of mean anodic polarization diagrams of bare, HCLCoat11, HCLCoat13 coated Al 5052-H3 in aerated 3.15wt% NaCl solution at 25.5°C

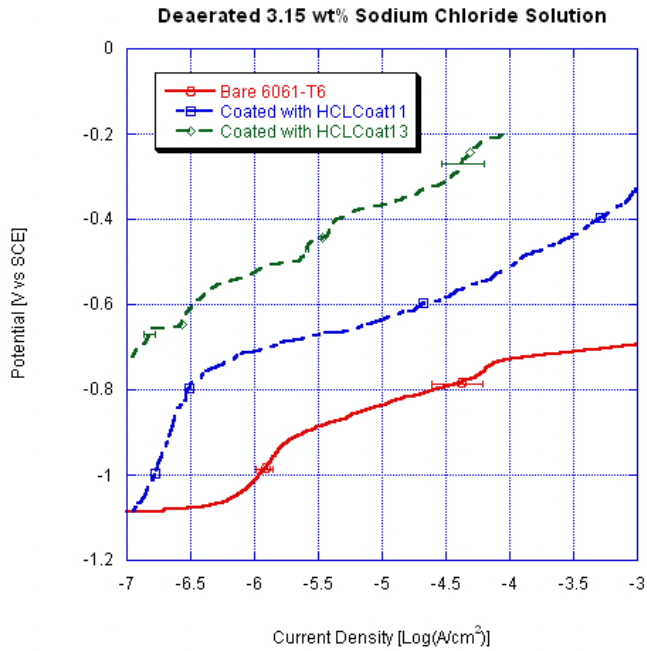
The anodic polarization diagrams of bare, HCLCoat11-coated and HCLCoat13-coated Al 6061-T6 are compared in deaerated (Figure 17) and aerated (Figure 18) 3.15wt% NaCl.

The pitting potentials were approximately  $-0.7V_{SCE}$  in deaerated 3.15wt% NaCl, and coincident with the open-circuit potentials in aerated 3.15 wt% NaCl. HCLCoat11 and HCLCoat13 also reduced the current densities compared to bare Al 6061-T6 by 2 or 3 orders of magnitude.

Figure 17: Comparison of mean anodic polarization diagrams of bare, HCLCoat11, HCLCoat13 coated Al 6061-T6 in deaerated 3.15wt% NaCl solution at 25.5°C

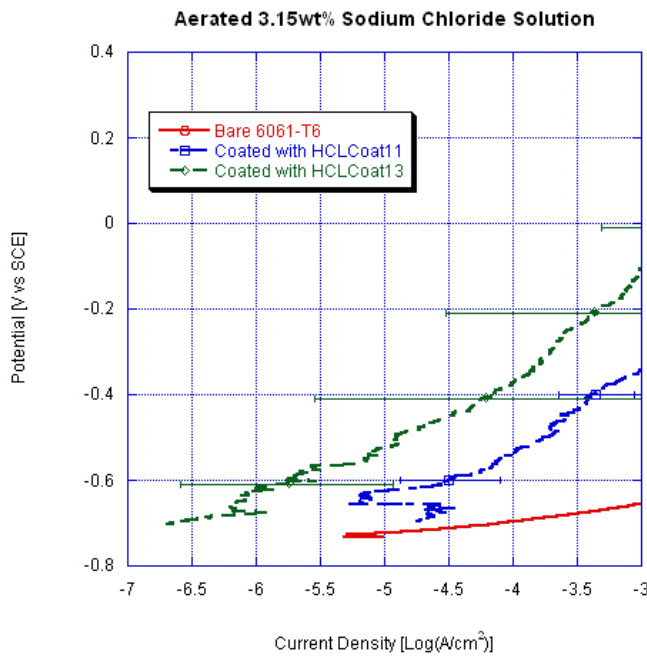
Figure 18: Comparison of mean anodic polarization diagrams of bare, HCLCoat11, HCLCoat13 coated Al 6061-T6 in aerated 3.15wt% NaCl solution at 25.5°C

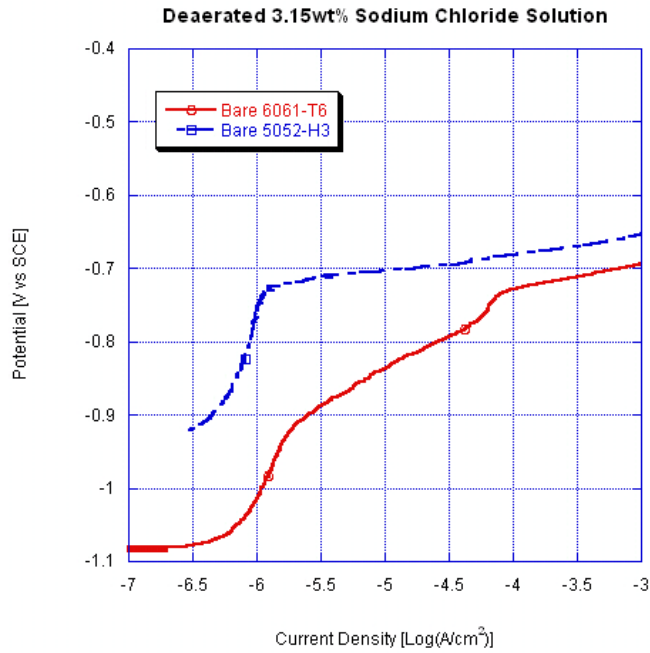
The comparisons of the anodic polarization diagrams of Al 5052-H3 and Al 6061-T6 in deaerated (Figure 19) and aerated (Figure 20) 3.15 wt% NaCl indicated that Al 5052-H3 has slightly better corrosion resistance compared to Al 6061-T6, as gauged by anodic polarization diagrams, but this does not necessarily indicate that Al 5051-H3 will outperform Al 6061-T6 in the field.

Figure 19: Comparison of mean anodic polarization diagrams of bare Al 5052-H3 and Al 6061-T6 in deaerated 3.15wt% NaCl solution at 25.5°C

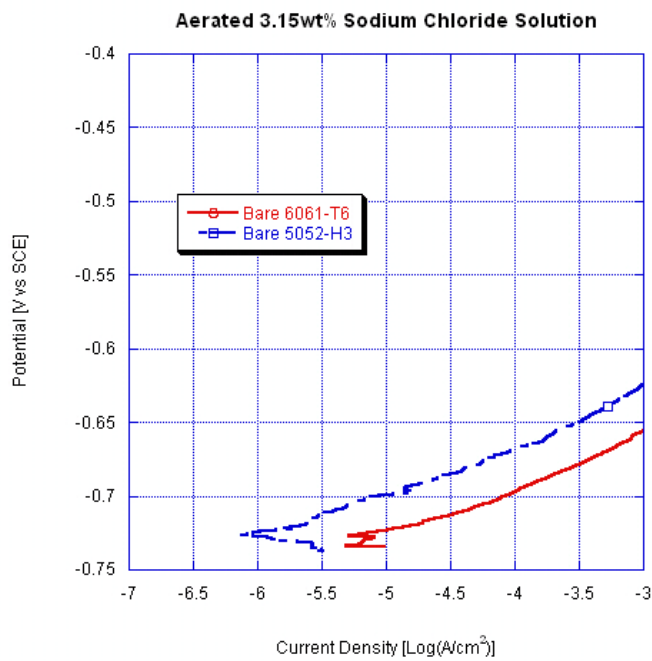
Figure 20: Comparison of mean anodic polarization diagrams of bare Al 5052-H3 and Al 6061-T6 in aerated 3.15wt% NaCl solution at 25.5°C
